ANNUAL REPORT FOR 2010

Turkey Branch Site J Mitigation Site
Madison County
TIP No. R-2518A

Prepared By:
Natural Environment Unit & Roadside Environmental Unit
North Carolina Department of Transportation
December 2010

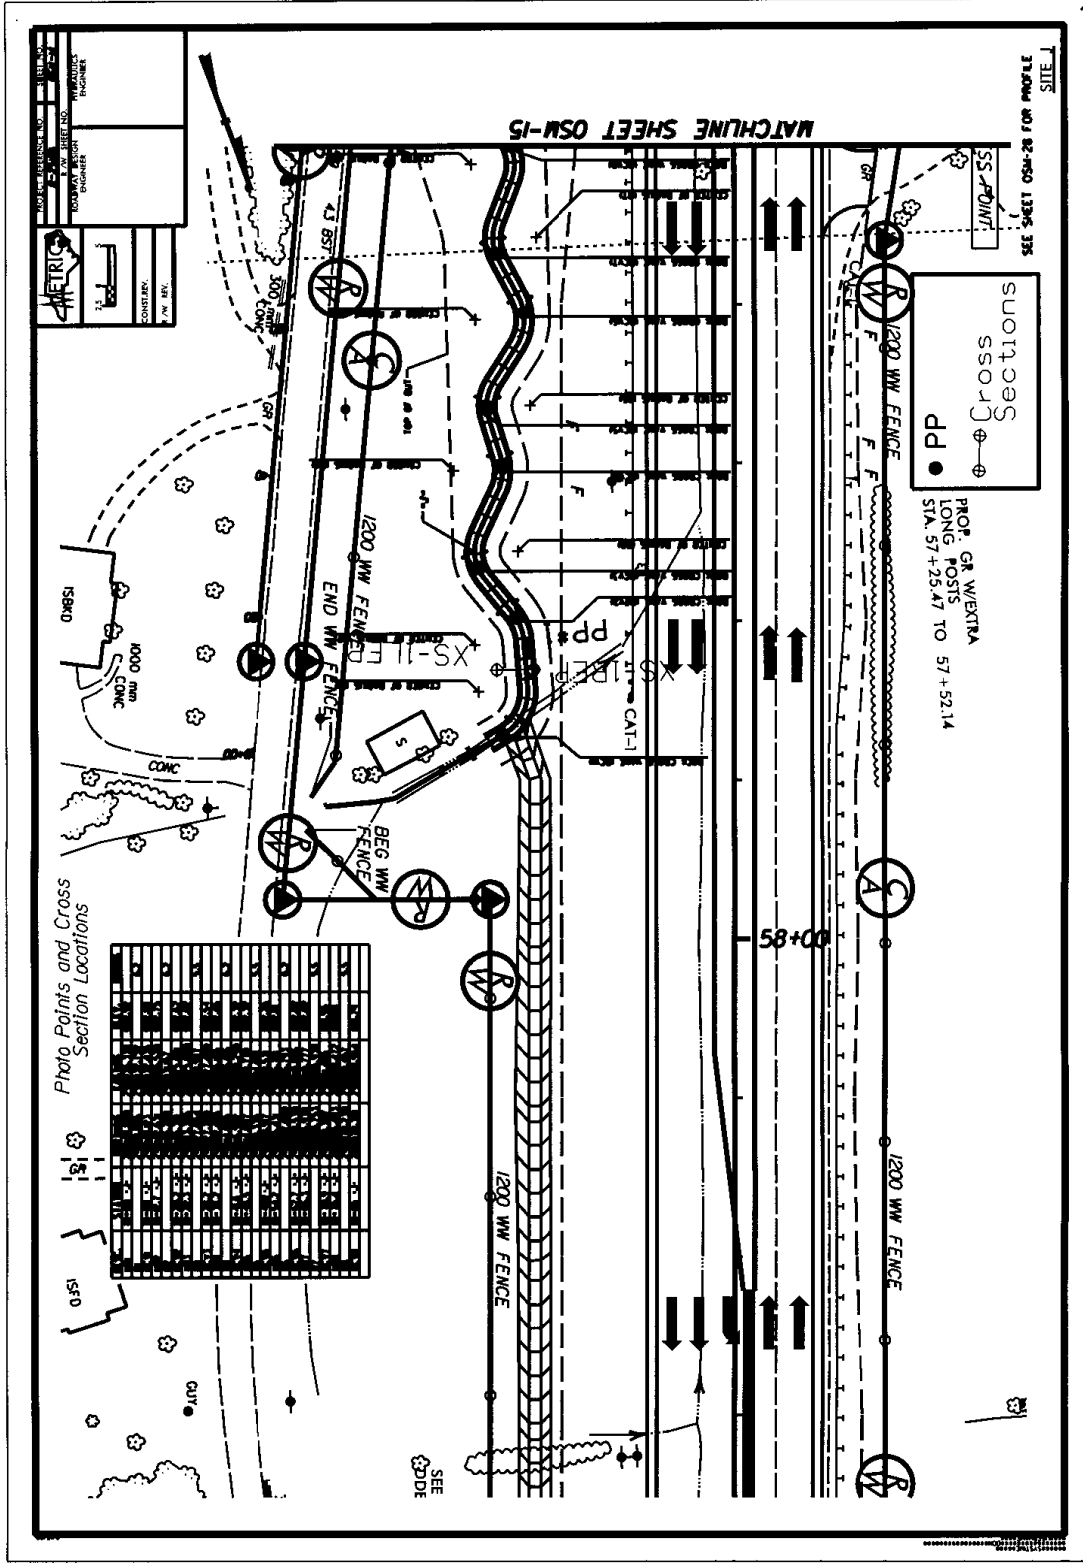
Figure 2. Site J Map

The following report summarizes the stream monitoring activities that have occurred during the Year 2010 at the Turkey Branch Site J Mitigation Site. Site J is located on US 19 in Madison County at Sta. 56+20 to 57+70 Rt. -L- (Figures 1 & 2). The Turkey Branch Site J was constructed to provide mitigation for stream impacts associated with Transportation Improvement Program (TIP) number R-2518A in Madison County.

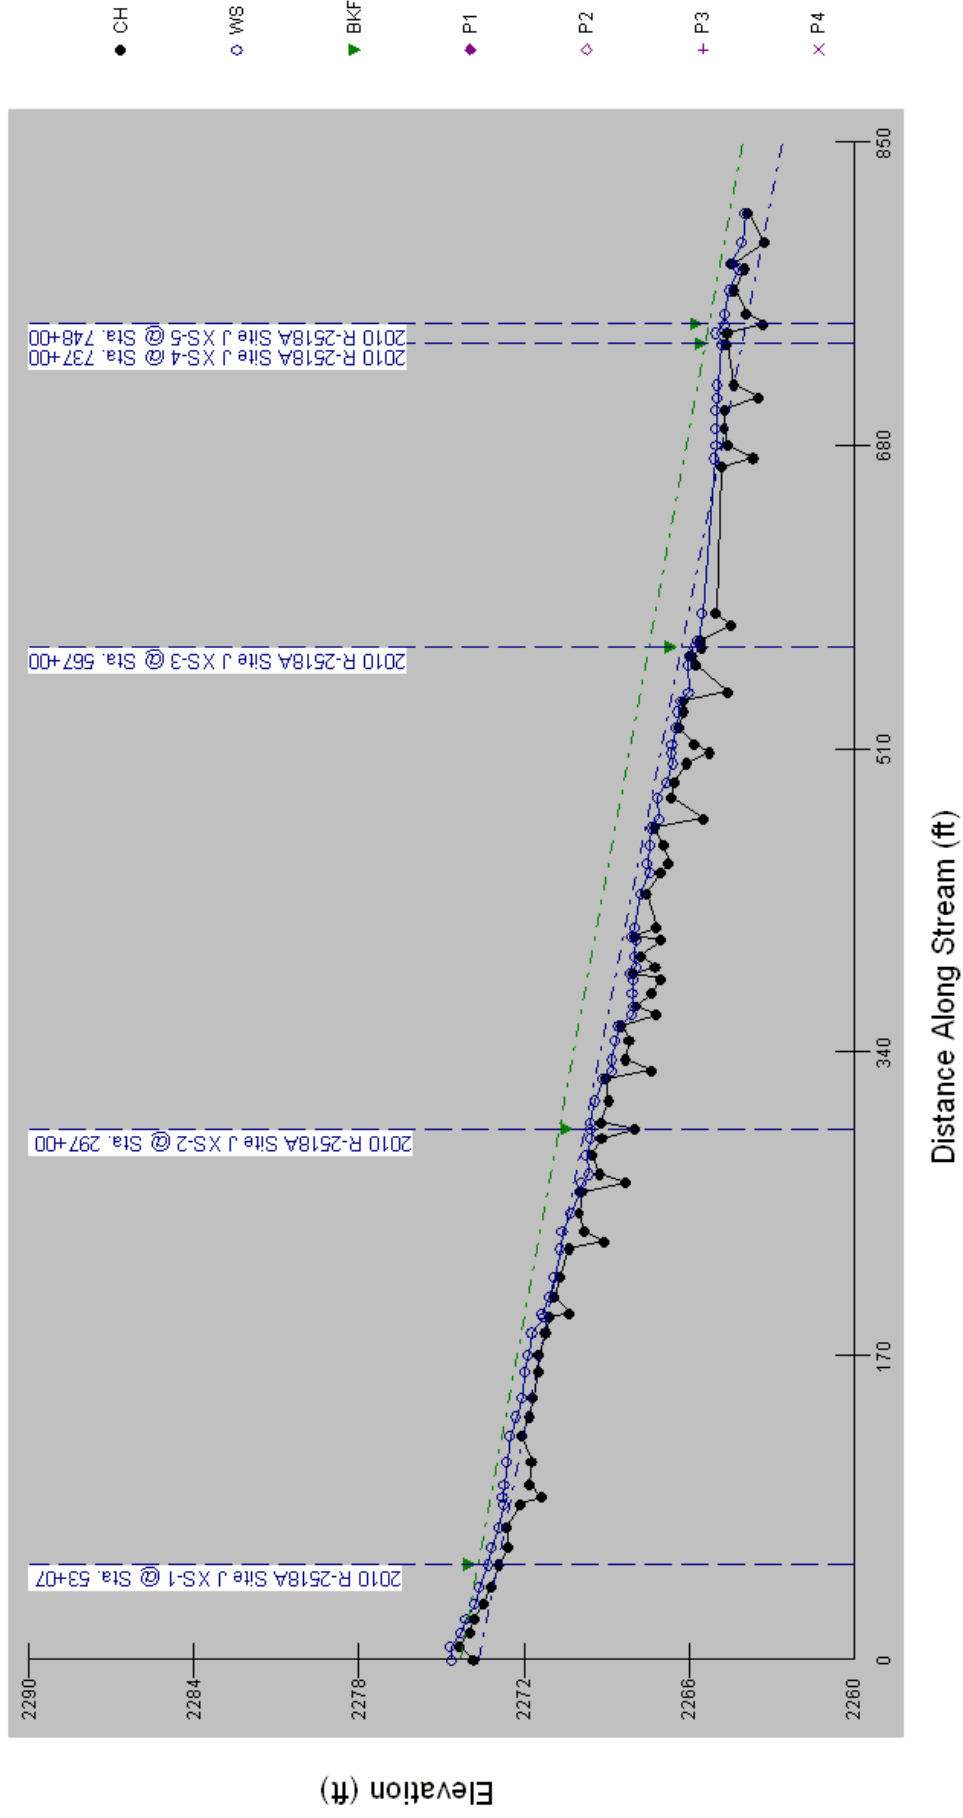
2010 R-2518A Site J Profile

Based on comparisons of the As-Built to Year 1 monitoring data, all of the cross sections appear stable with little or no active bank erosion. Graphs of the cross sections are presented in Appendix A. Future survey data will vary depending on actual location of rod placement and alignment; however, this information should remain similar in appearance. The longitudinal profile showed that the channel was stable for the 2010 monitoring evaluation. Pebble counts were not required per the permit conditions and therefore were not completed.
